## EVALUATION OF AFTERSHOCKS IMPACT ON SEISMIC SAFETY OF POWER PLANTS BASED ON EXPERIENCE FEEDBACK

**Abstract:** Nuclear power plants (NPPs) are particularly vulnerable to the effects of aftershocks because they have complex and sensitive structures that require high levels of integrity to function safely. If the structural integrity of a nuclear power plant is compromised by an aftershock, it could lead to a serious accident with potentially catastrophic consequences for public health and the environment.

This paper focuses on work package 6 of Euratom METIS project, which concerns fragility analysis. One of the primary objectives of WP6 is to evaluate the impact of aftershocks and clustered seismicity on the seismic fragility and safety of NPPs.

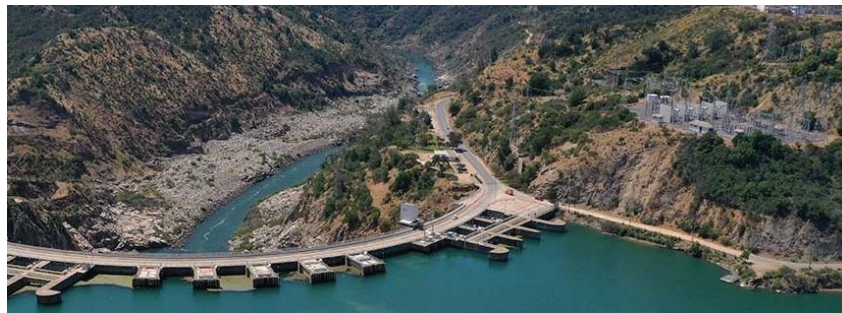
- *Mainshock Damage Assessment:* During the earthquake, none of the five turbines were in operation. Afterward, a minor inspection revealed only slight damage to the dam. The emergency diesel ran for 24 hours until three units were brought online; two remained offline due to foundation movement. The delayed startup was mainly due to 220 kV switchyard damage. Equipment in the control building suffered minor damage, while cable trays and conduit remained unscathed.

- *Aftershock-Induced Damage:* In the days following the earthquake, more damage to the dam was discovered. The direct cost of damage at the facility was estimated at \$20 million with an additional loss of approximately \$11 million due to the unavailability of Units 3 and 5. Little or none of the damage was attributed to the aftershock.

Figure 3: Rapel Hydroelectric

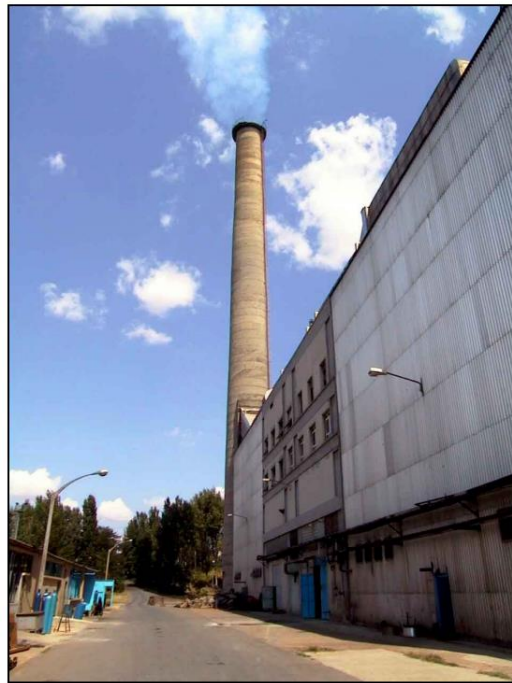
Figure 4: Stack for Units 4 and at Ambarli Fuel Oil Plant
